Building Envelope Maintenance Report

January 2010

**Sample Building
Sample St
Vancouver, BC**

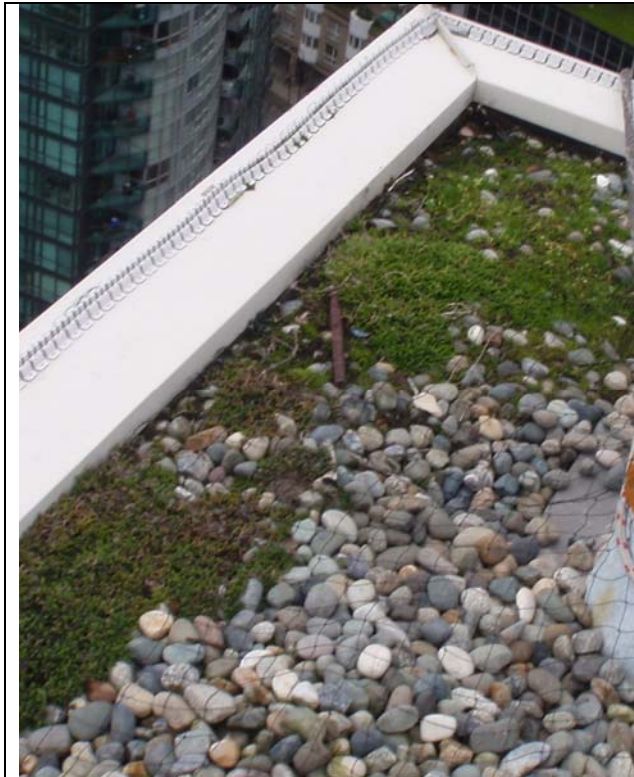
Small amounts of moss were noted in some flat roof areas (Photo1). The moss should be removed in a timely manner.

Photo # 1 – Moss on roof

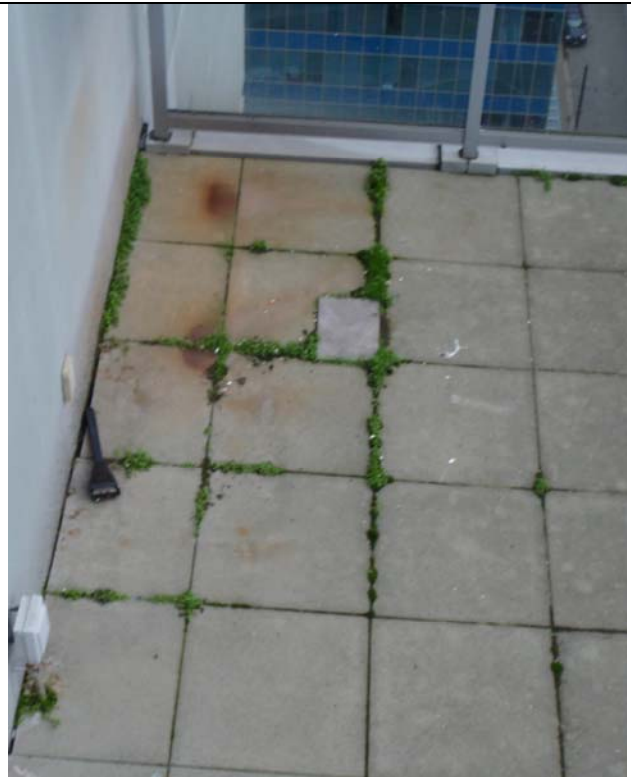
The roof decks drain through surface drains located in the field of the decks. In all those areas reviewed, the drains appeared clean and free flowing. Flashings and railings in the roof deck areas also appeared in good condition at this time. Moss was present in a number of locations between the concrete pavers (Photo 2). The moss should be removed as soon as practical, and a program implemented to regularly remove organic growth from the roof deck areas.

Photo # 2 – Organic growth on roof deck

Residents should clean and inspect the roof deck areas on a regular basis. Plants and other organic materials should be removed from between pavers and at deck perimeters.

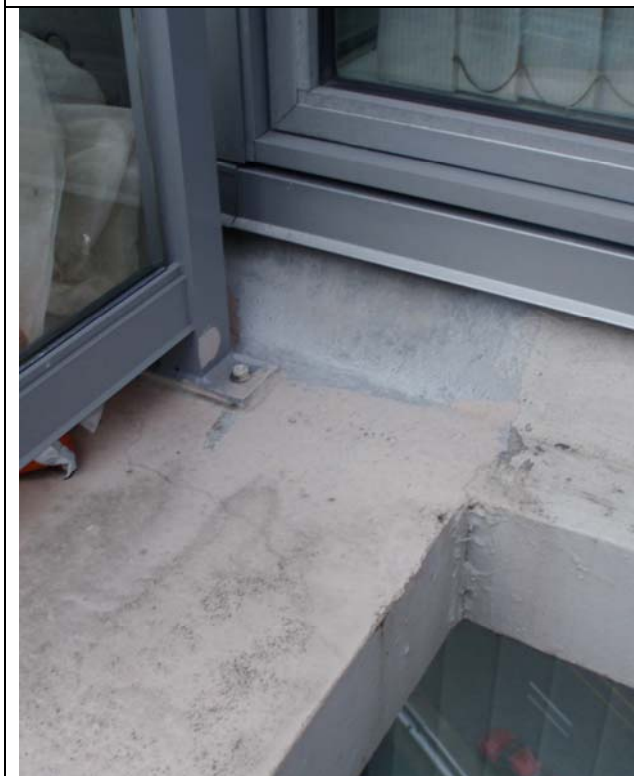
In the majority of locations, the balcony coatings appeared in good condition with no signs of cracking, blistering or peeling noted. There were, however, a number of areas where the balcony membrane was noted as blistering, peeling, or as missing (Photo 3 - 4). The balcony membrane in these areas should be repaired or replaced in a timely manner. Varying amounts of dirt were observed in some balcony locations, and should be cleaned as required.

Photo # 3 – Missing membrane

Residents should regularly clean the balcony surface, checking the condition of the coating for any cracks, blisters, cuts or burns. Damaged areas should be repaired in a timely manner.

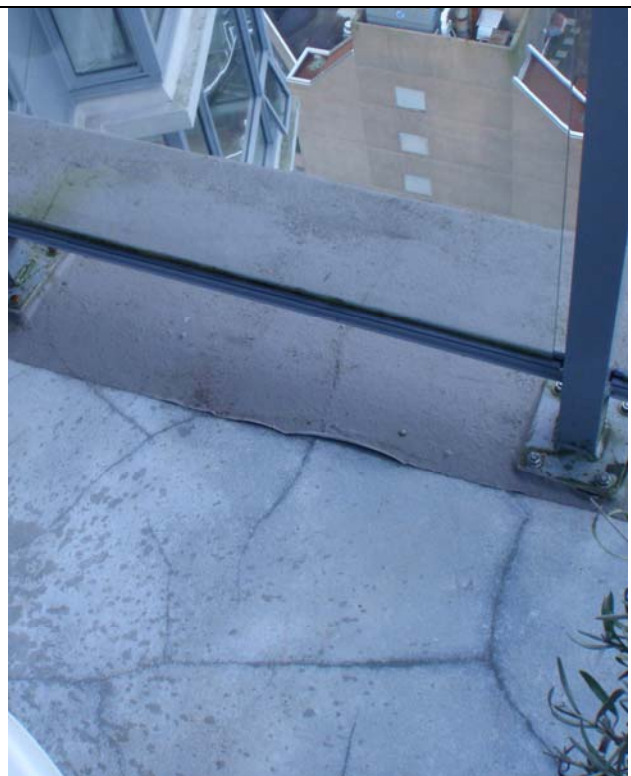
Photo # 4 – Missing membrane and cracks on balcony

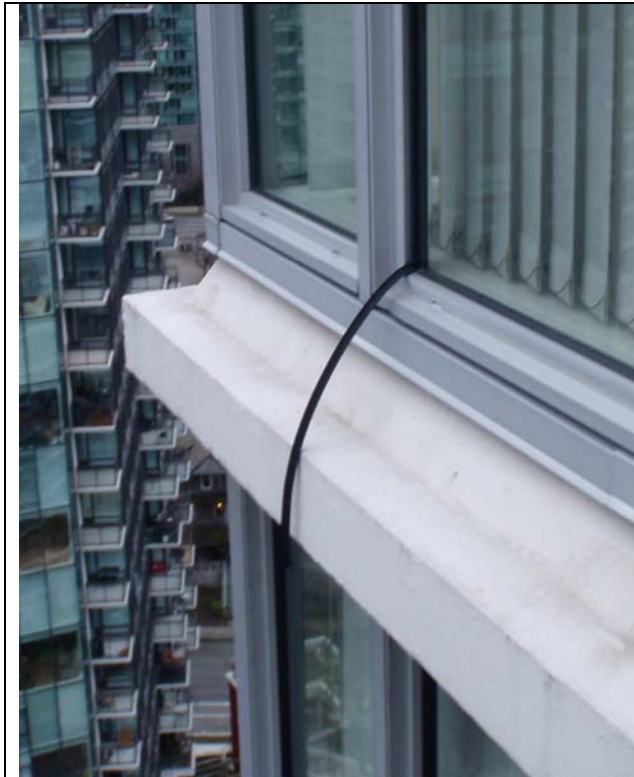
In general the window units all appeared in good condition. Sealant was noted as missing or failed in some window locations. Broken glazing was observed in some areas, and in some locations, gaps were noted at the junction of metal panels with the window framing. The window glazing gasket was noted as hanging loose in one location on the East elevation of the building (Photo 5). All of the noted conditions should be rectified as soon as practical.

Photo # 5 – Loose window gasket

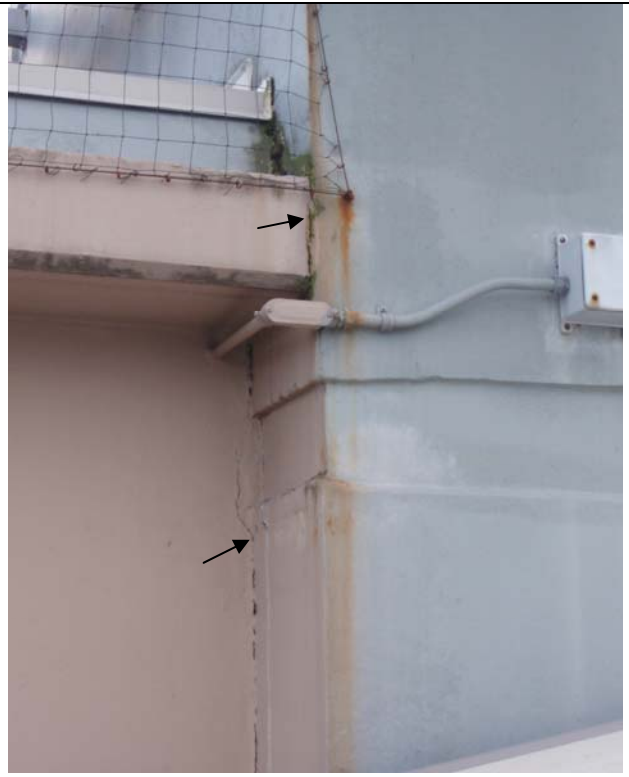
Cracks were noted in the exterior concrete walls at the Sample Building in a number of locations around the building (Photo's 6 - 9). As noted on the elevation drawings, cracking was common to some details, and was present in these areas at each floor. The concrete was also noted as chipped in a few areas (Photo 10). In all locations, cracks in the concrete should be repaired as soon as practical.

Photo # 6 – Cracks in concrete

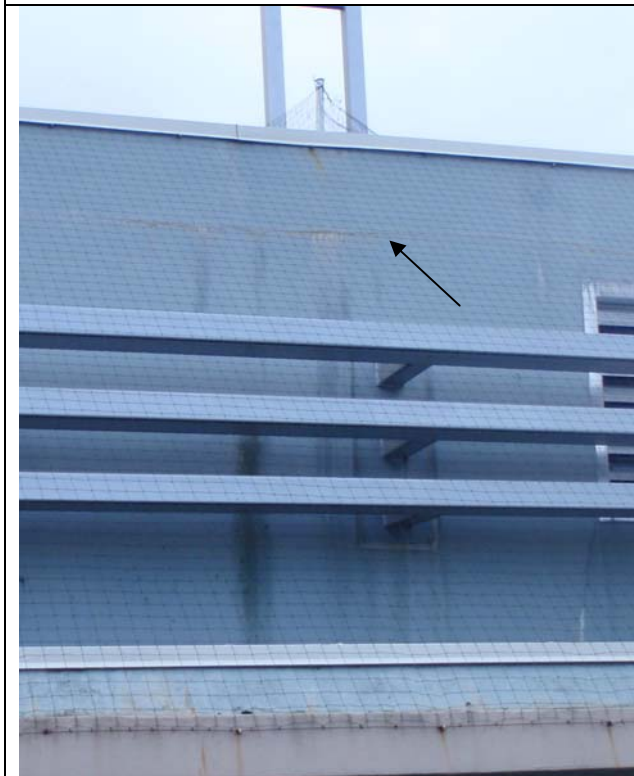
Photo # 7 – Horizontal crack in concrete

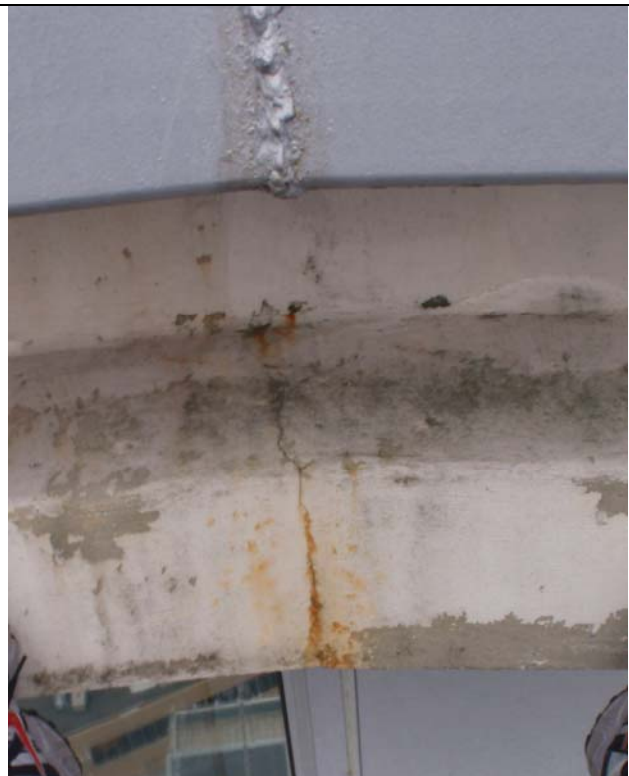
Photo # 8 – Crack in concrete

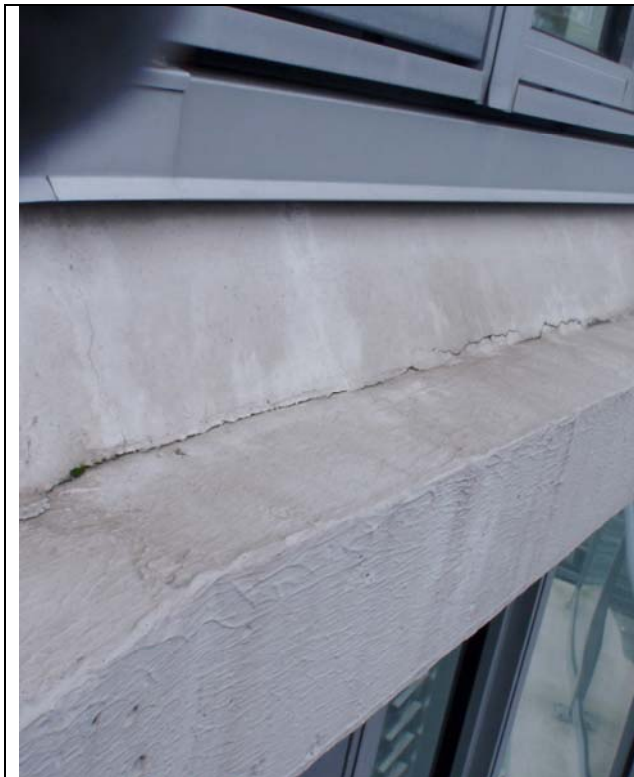
Photo # 9 – Horizontal crack in concrete

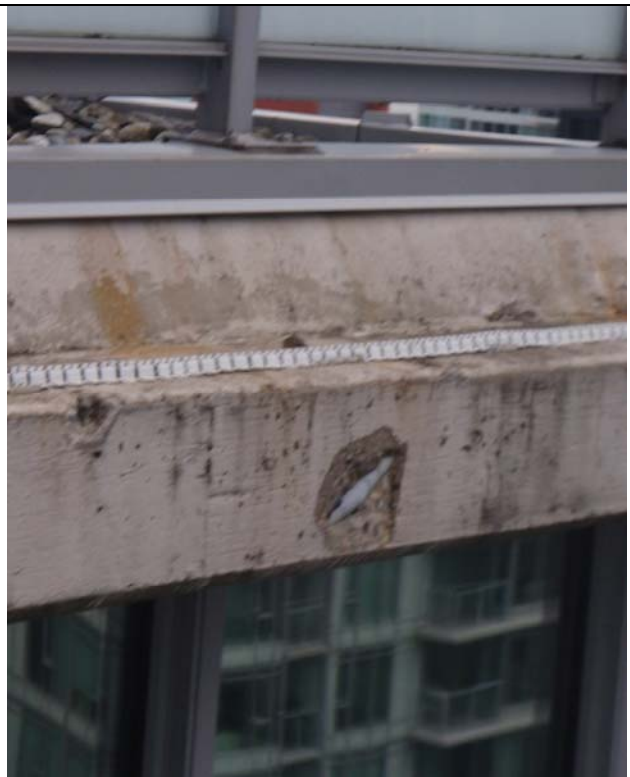
Photo # 10 – Chipped concrete

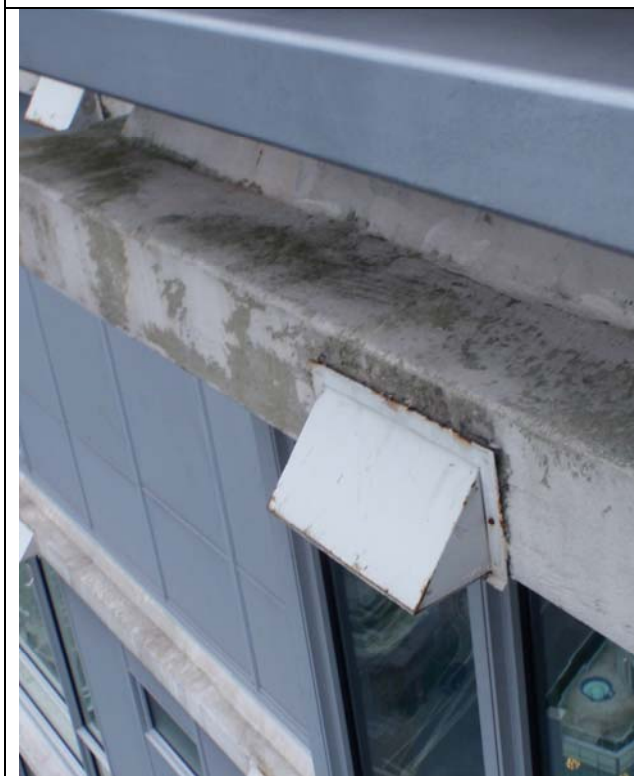
At the Sample Building, the paint over the concrete was observed to be missing in a few locations, and was noted as blistering or peeling in others (Photo 11). In all of these areas, the substrate should be cleaned, and a new paint coating applied.

Photo # 11 – Paint peeling and missing sealant at vent cover

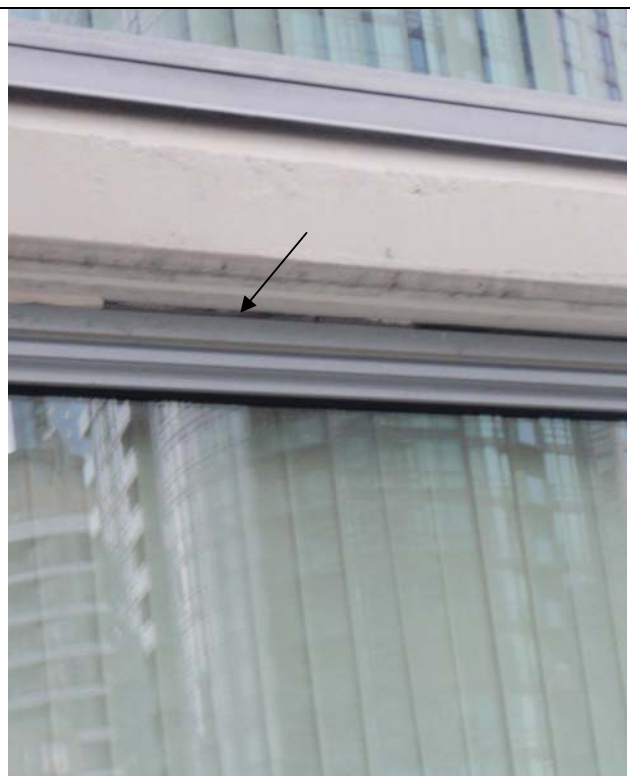
In general the exterior sealant at the Sample Building appeared in good condition, however sealant was noted as separating in some locations, and missing in other areas (Photo's 12 – 14). Sealant separations are not common to any particular detail or location around the building.

Photo # 12 – Missing sealant at window head

In all areas, sealant should be installed where missing, and repaired where failures have occurred.

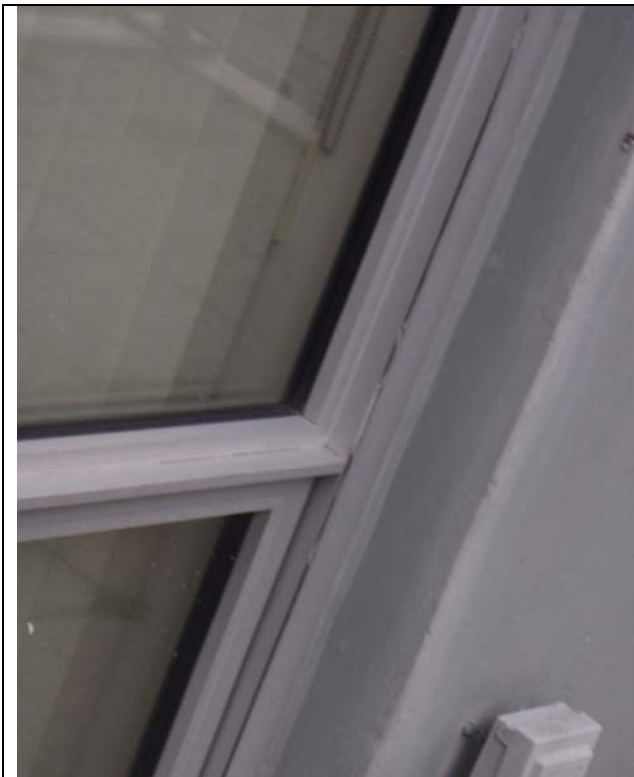
Photo # 13 – Missing Sealant

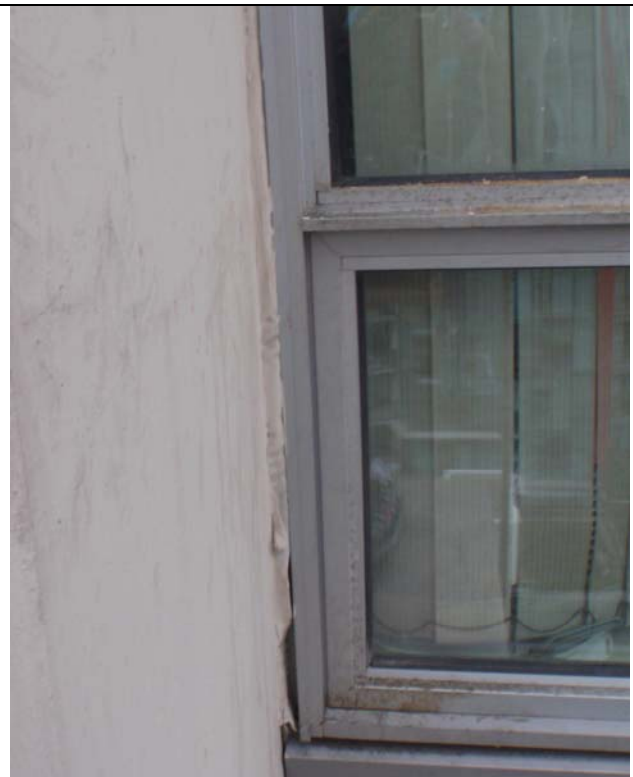
Photo # 14 – Sealant separation at window jamb

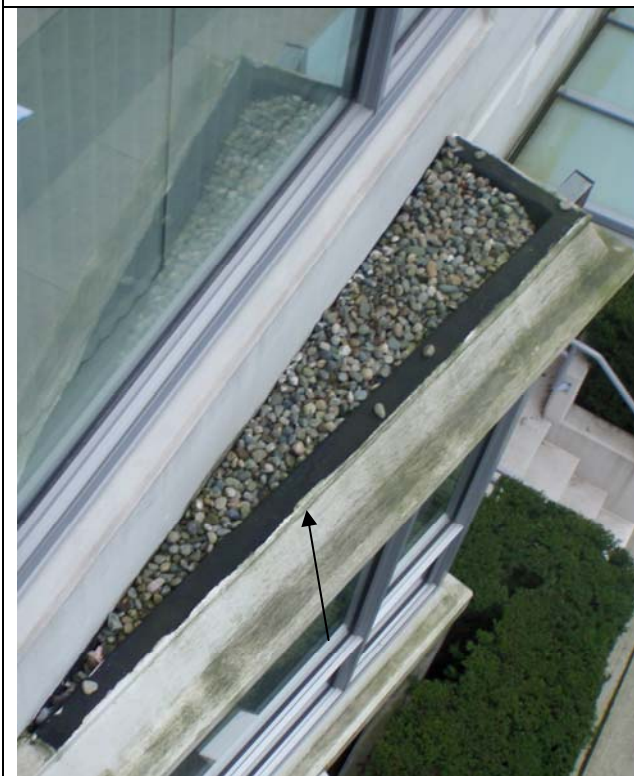
The flashings around this complex appeared in good condition. Where applied the cap flashings that protect the concrete roof curb walls were in good condition. As previously noted, flashing was noted as missing in some locations including ancillary roof perimeters, and gumlip flashing at roof deck perimeters (Photo 15). Flashing should be installed in all locations where required to direct water or protect waterproof membranes or other building components.

Photo # 15 – Missing flashing at ancillary roof

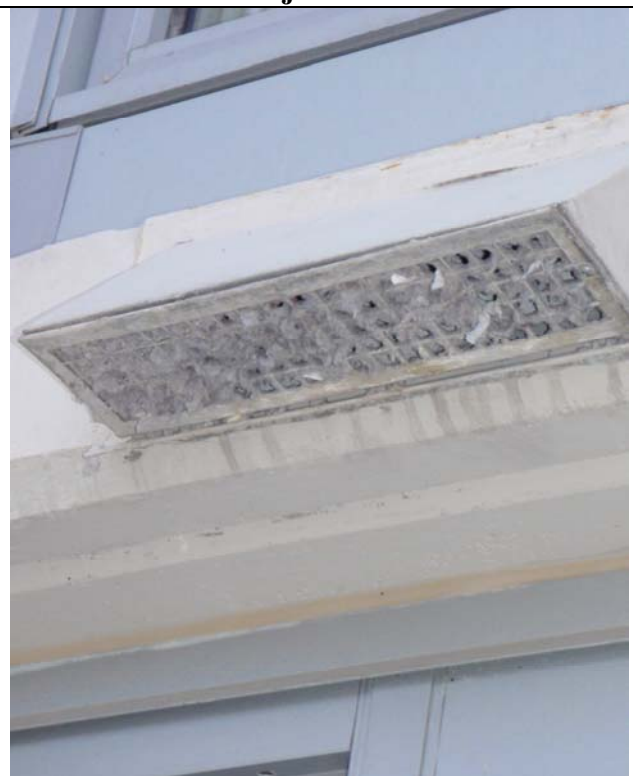
The exterior vents were clear and free of lint in some locations, however there were a number of areas observed where vents were plugged or partially plugged (Photo 16). There were also a number of locations noted where the vent cover is loose (Photo 17) or is missing (Photo 18). In one location, a birds nest was present in the ducting as the vent cover was missing.

Photo # 16 – Plugged vent screen

It is important that a regular program be implemented to remind residents to clean the exterior vent covers, as well as to arrange for professional cleaning of the dryer ducting. A poorly maintained dryer vent can lead to moisture problems and staining within the building. Where accessible, exterior vent covers should be vacuumed by residents quarterly, and professionally cleaned annually. Dryer lint traps should be cleaned regularly to help minimize the build up of lint in the ducts as well as at the exterior vent.

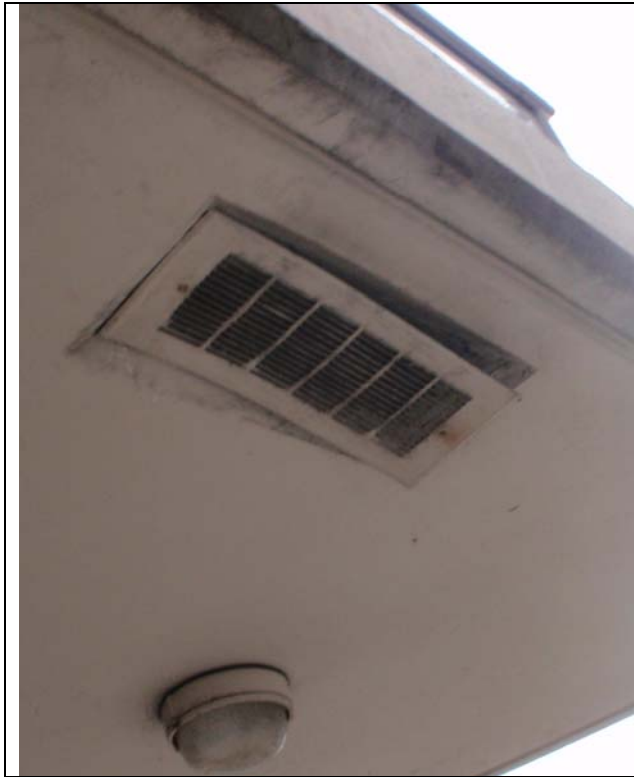
Photo # 17 – Loose vent cover

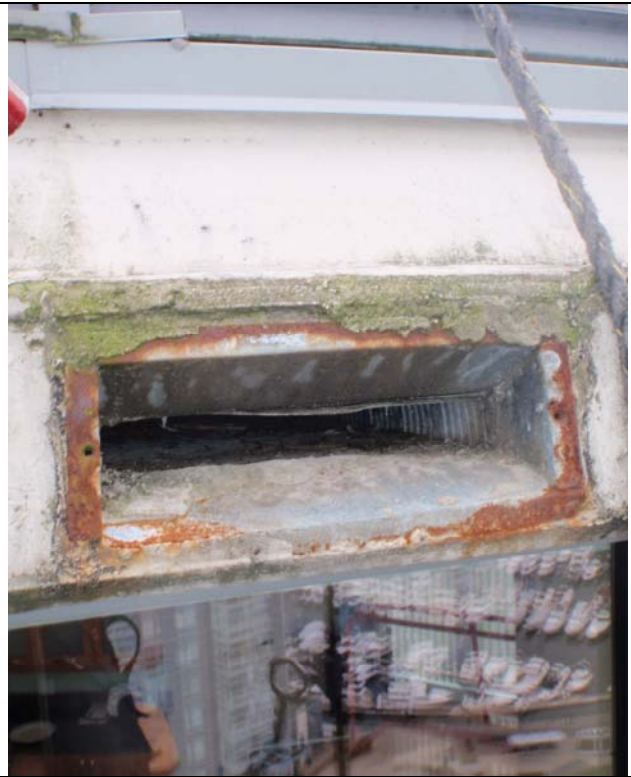
Photo # 18 – Missing vent cover

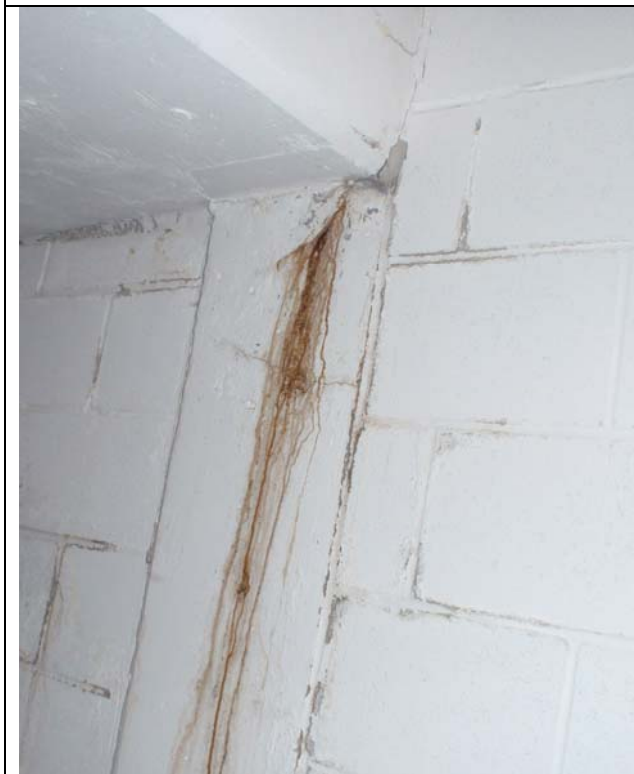
A 3 level below grade parkade services the Sample building. The concrete floors have been finished with a urethane base traffic coating. As is common, cracks were noted in the ceilings and walls of the parkade (Ceiling at ramp between stall 22 and 49 (Photo 19) / Ceiling at stall 64). None of these cracks appeared to be active at this time. All cracks should be visually monitored to determine if they are active. If moisture is seen emanating from the area of a crack, the area must be further investigated, and the crack sealed.

**Photo # 19 – Moisture and staining on wall at
parkade ramp**

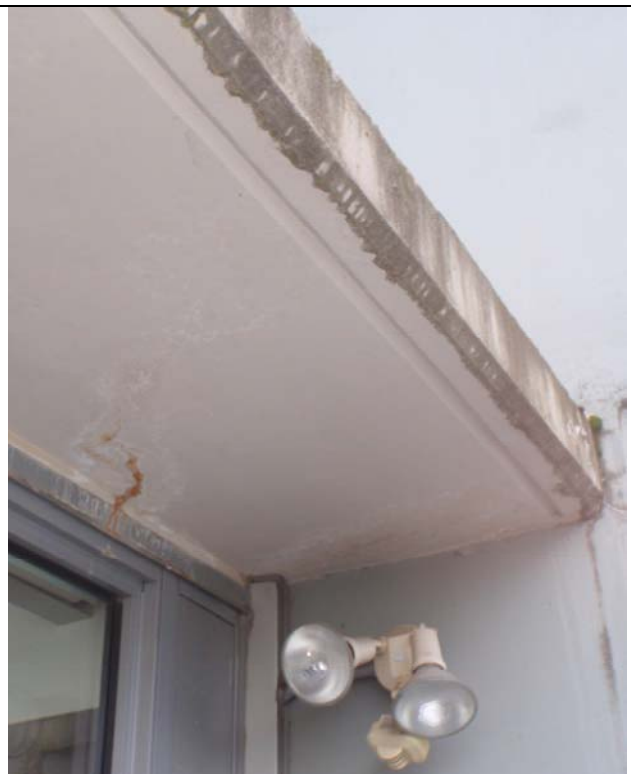
- Cracks are present in the exterior concrete wall and ledge above the kitchen window (Photo 20)
- Staining at interior window head (Photo 21)
- Cracks are present in the concrete balconies (Photo 5)
- The waterproof membrane has peeled off on one balcony (Photo 5)

Photo # 20 – Cracking at unit 2801

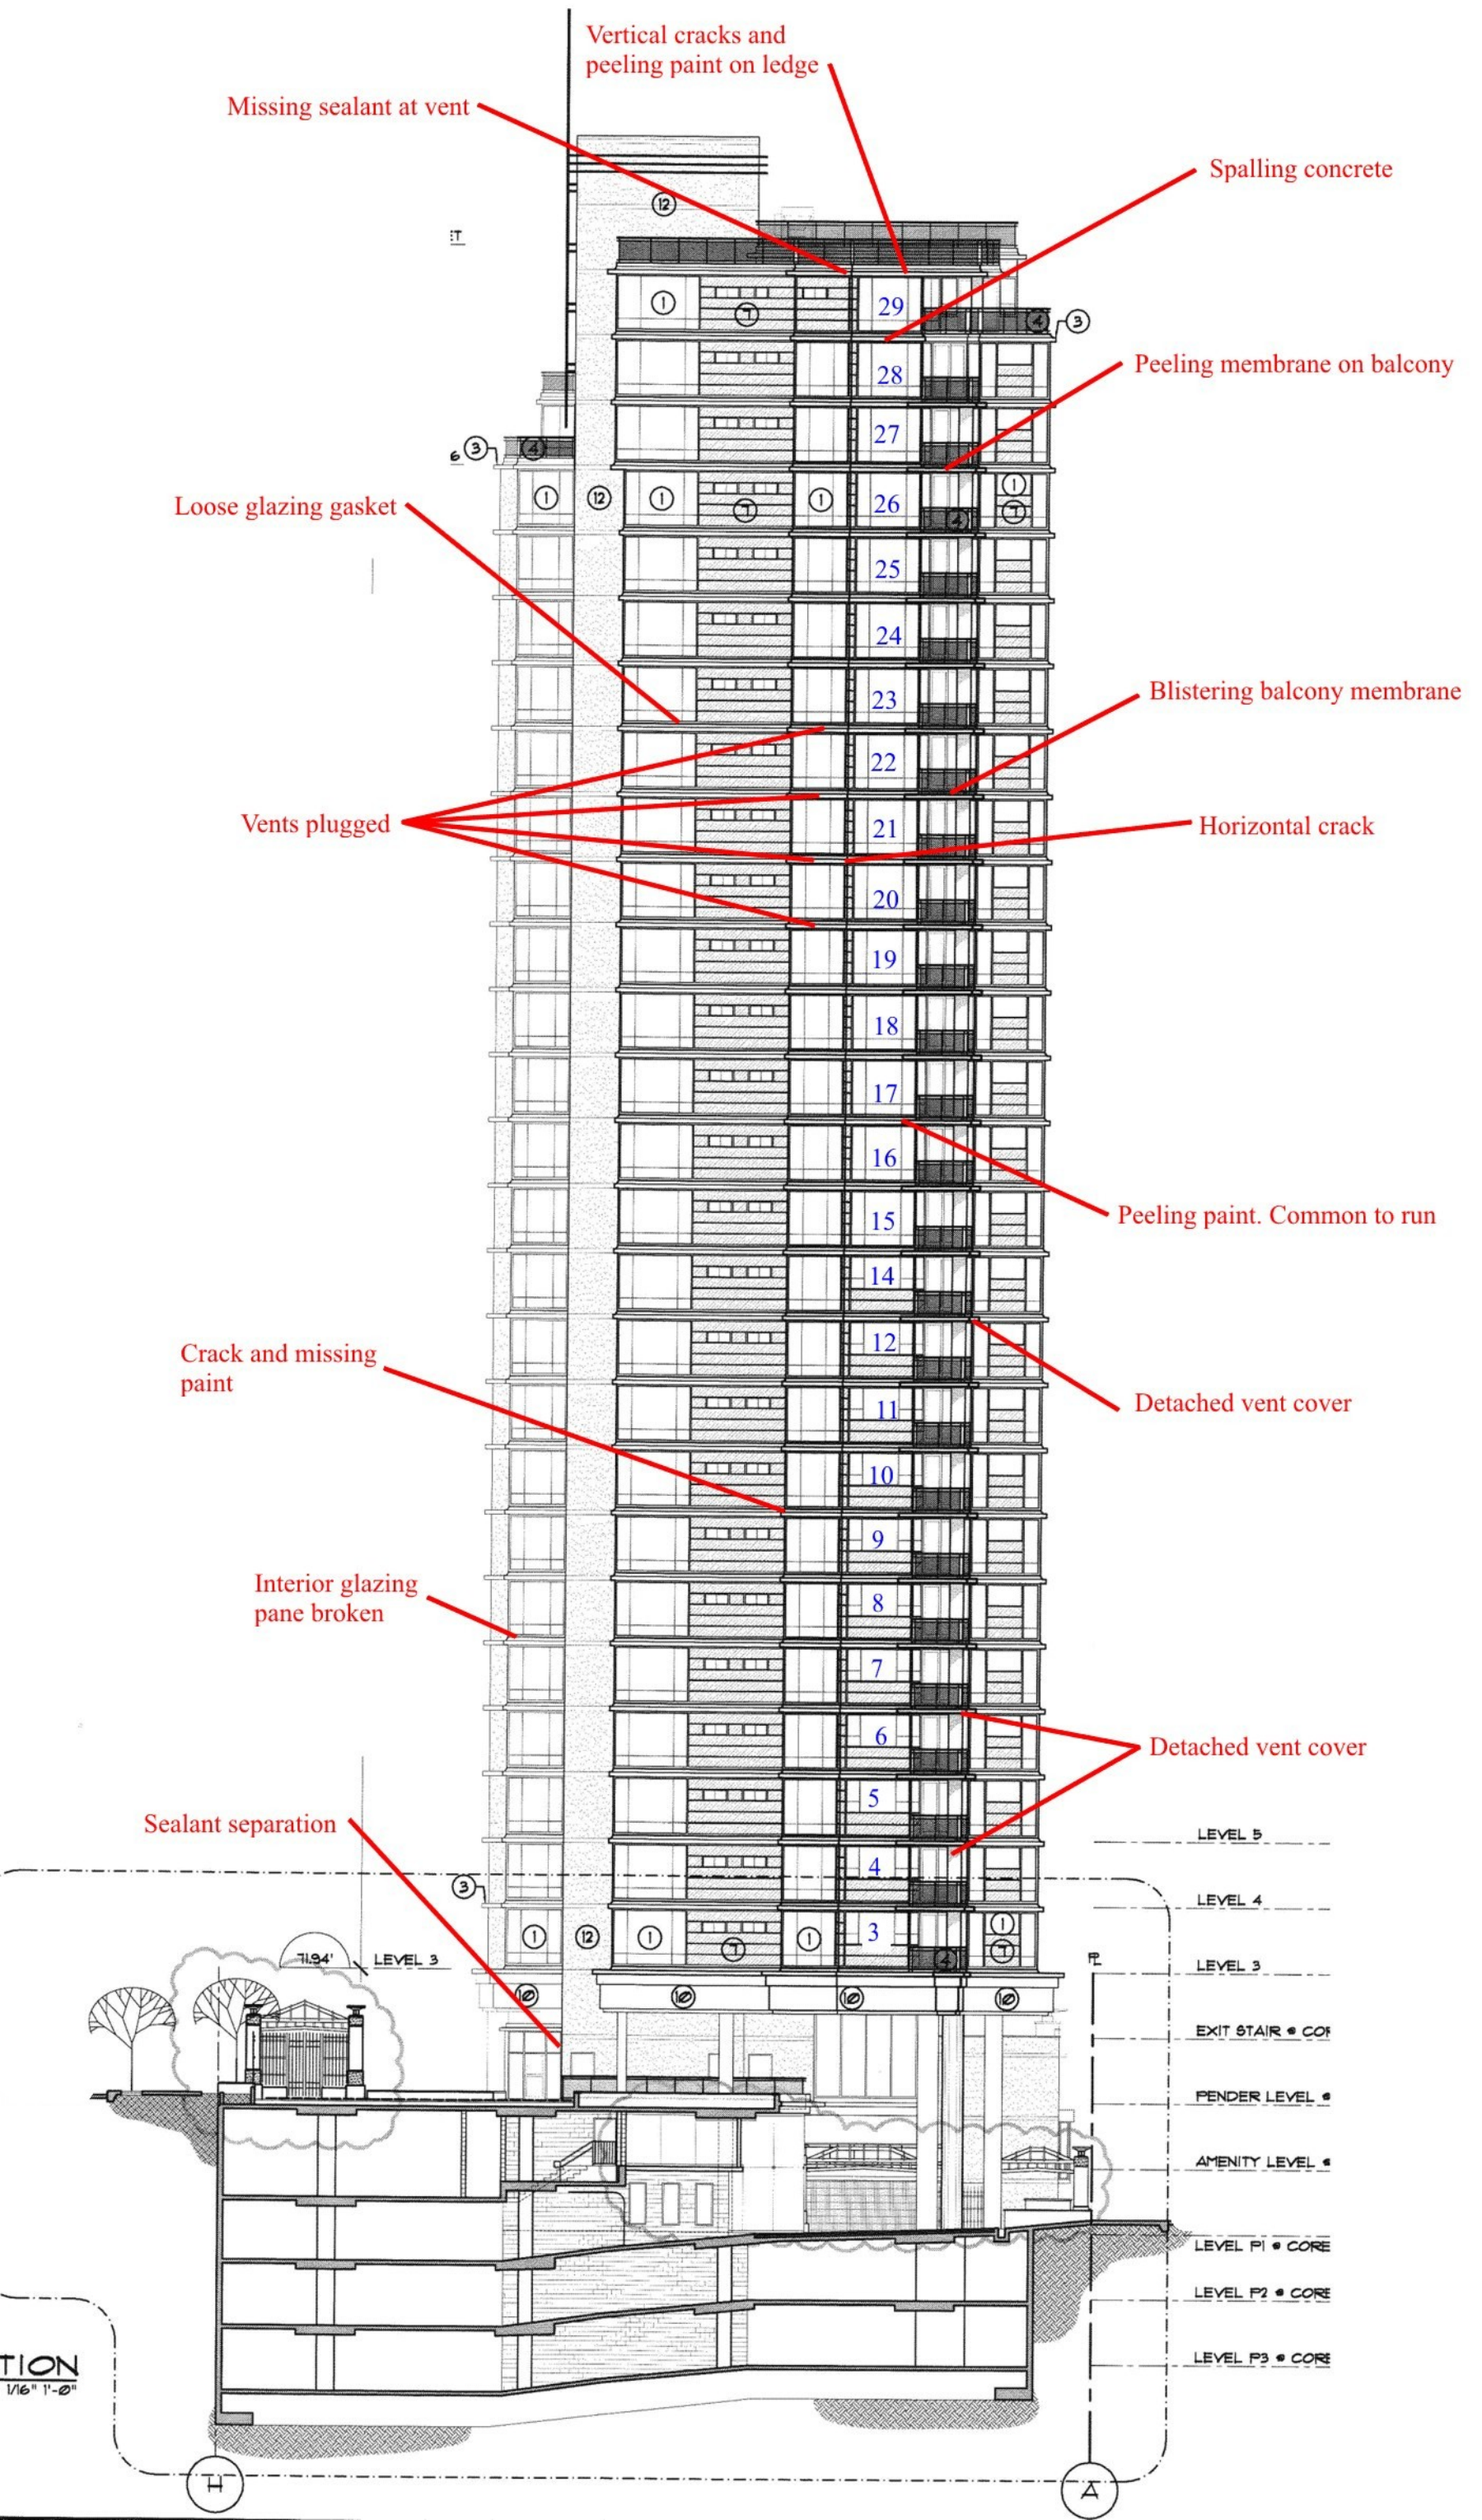
Vertical hairline cracks.
Common to run.

Missing vent cover.
Birds nest in vent.

Moss on roof deck

Vent plugged

Balcony very dirty

Vent detached. Cracks
with efflorescence.

Vent detached

White gravel on deck membrane

Roof deck membrane
exposed

Vertical crack

Missing cap
flashing
